Replacing a damaged riser tube

In the event of a riser getting damaged and leaking, one of the advantages of Heliocol collectors is the ease with which the leaking riser can be removed, the leak repaired, and a replacement riser attached to maintain the uniform appearance of the panel.

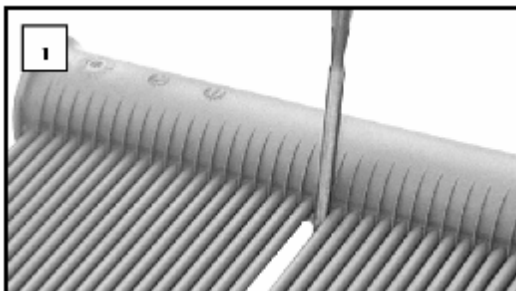
1 Using a 7 mm chisel, and holding the flat side of the chisel towards the header, cut through the damaged riser, flush against the header. A round hole is created in the manifold header.

Repeat at other end of riser and save the removed riser for use in the repair.

Important: Do not use a chisel more than 7mm wide, as you might damage the adjacent risers as you remove the broken riser.

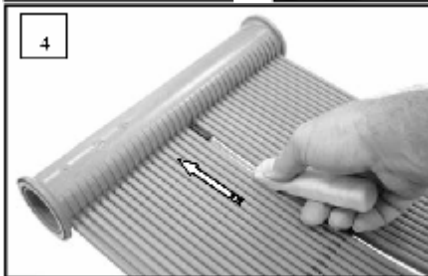
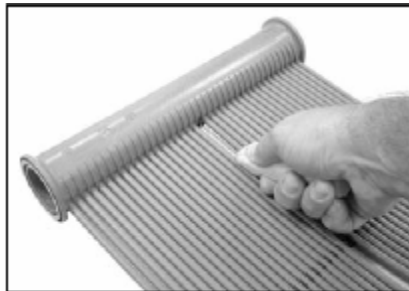
2 Spray the rubber sleeve with silicon spray and pull it over the small metal pin of the Heliocol repair handle.

3 Stretch and relax the rubber sleeve couple of times over the metal pin.

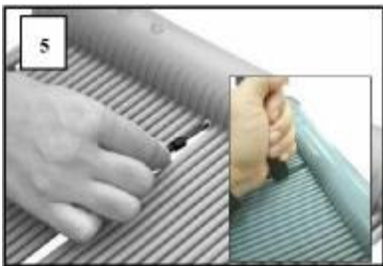
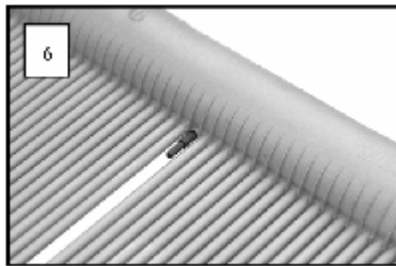
4 Using the repair handle gently push the rubber sleeve into one of the holes created by the removal of the riser, until only the head is showing.

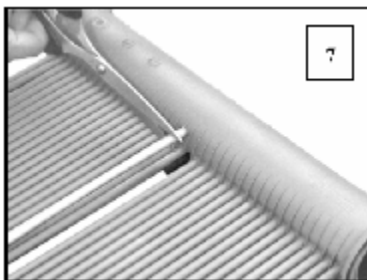
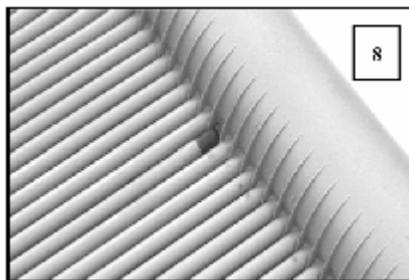
5 Push a plastic repair plug all the way down into the repair sleeve. You may use the rear part of the handle to push it firmly into the sleeve.

6 The hole is plugged and will not leak.

Repeat steps 4 and 5 for the hole in the header at the other end of the panel.

7 Cut the removed riser so it fits exactly between the broad heads of the plastic pins.

8 Fit the riser onto the stubs of the two repair plugs.

The panel is now leak free while its uniform appearance is restored.
